**Docket No. 217 – Development and Management Plan Inspection**

Northeast Utilities Service Company Certificate of Environmental Compatibility and Public Need for the construction of a 345-kV electric transmission line and reconstruction of an existing 115-kV electric transmission line between Connecticut Light and Power Company's Plumtree Substation in Bethel, through the towns of Redding, Weston, and Wilton, and to the Norwalk Substation in Norwalk, Connecticut.

**Date:** July 12, 2005

**Location:** 345kV XLPE Component

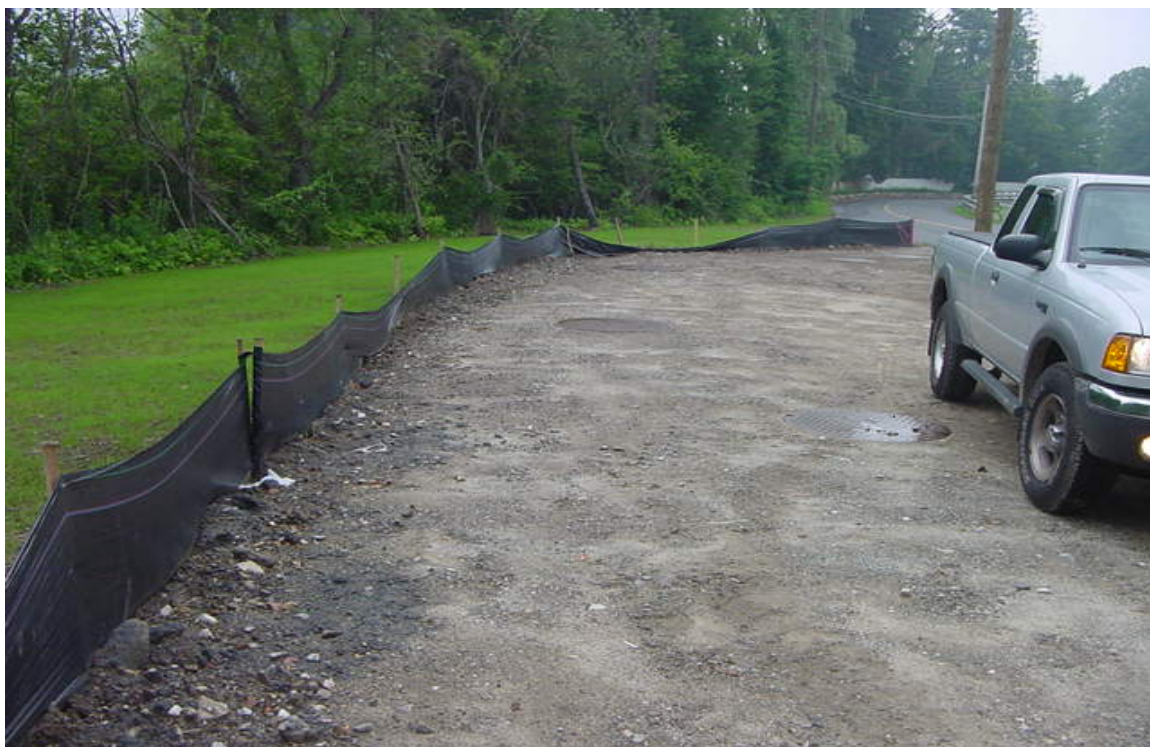
345kV XLPE: Photo shows the vault 2 area, well restored with erosion controls moved closer to the vault manholes. Vegetative cover is establishing in the adjacent areas. 7/12/06

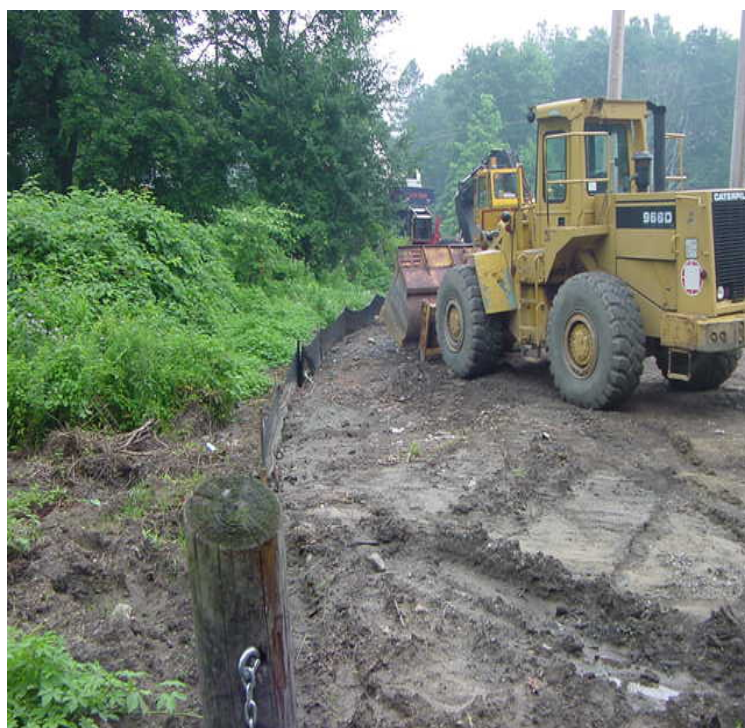
Photo on the left shows some of the disturbance caused by accessing the stream work. However, silt fence remains in place and the area will be restored following work. Photo on the right shows a view of the bore pad area. 7/12/06

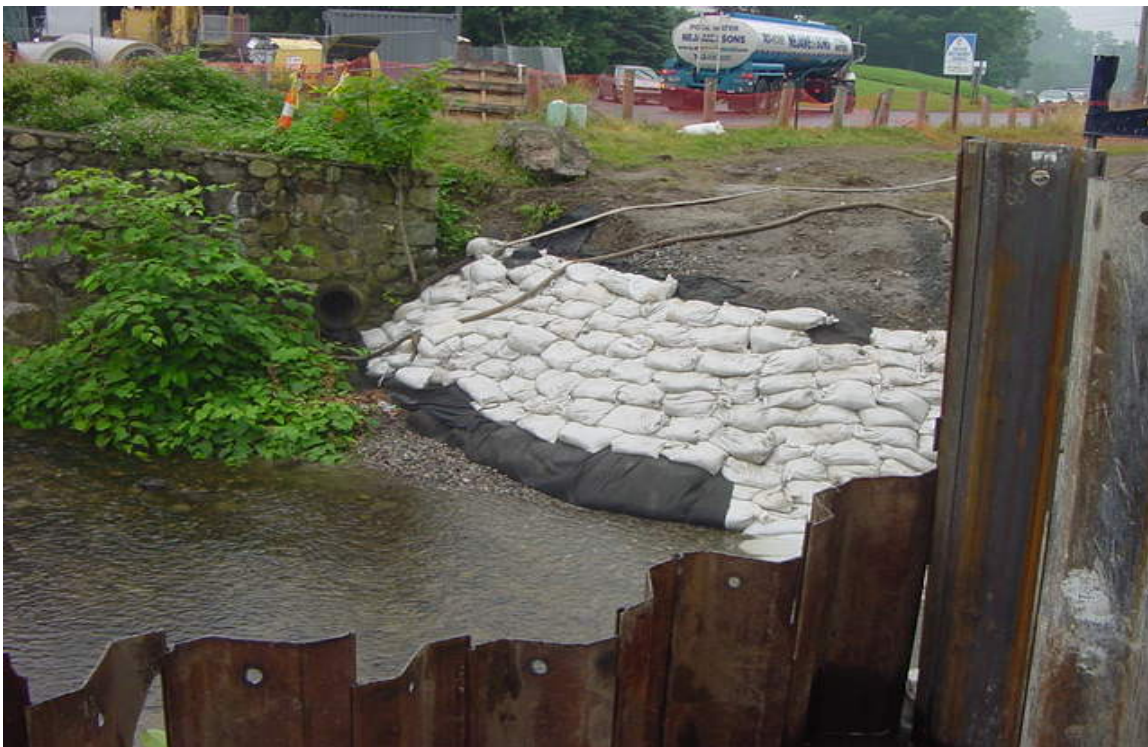
Photo shows the sandbags in place on the opposite streambank where the sheet piling had previously been. The sheet piling was shifted and the instream area was restored. 7/12/06

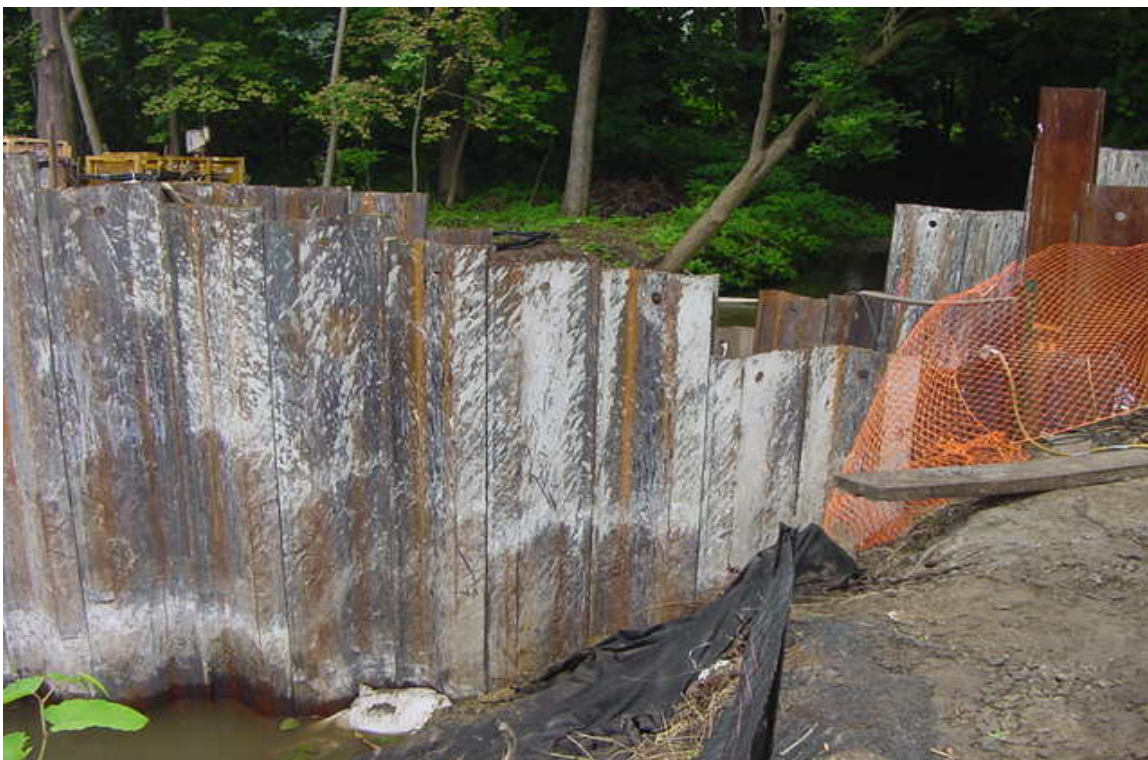
Photo shows a view of the sheet piling at the receiving pit side of the stream. 7/12/06
